NOTICE REMPLACEMENT TERMINAL V30 – 33TZ ENCASTRE
V30 Remplacement des références 7245509, 7245510 et 7166780 par le 7580208
V30 – 33TZ Flush-mounted terminal replacement

V30 – 33TZ Flush-mounted terminal replacement

Codes 7245509, 7245510 & 7166780 changed to 7580208

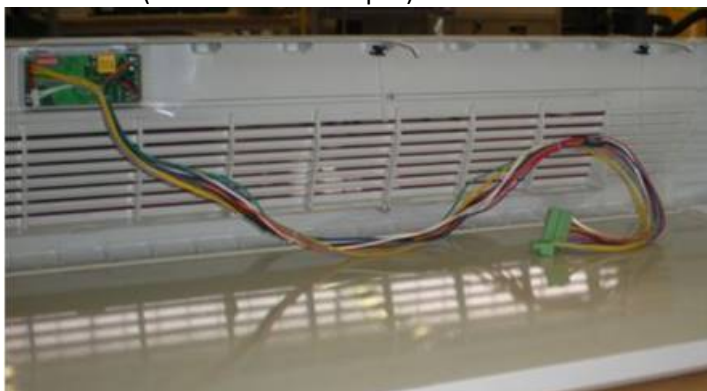
1- Démontez la carrosserie après avoir débroché les deux connecteurs de l'ancien terminal

2- Détacher le faisceau de câbles du terminal de la carrosserie (collier rilsan à couper)

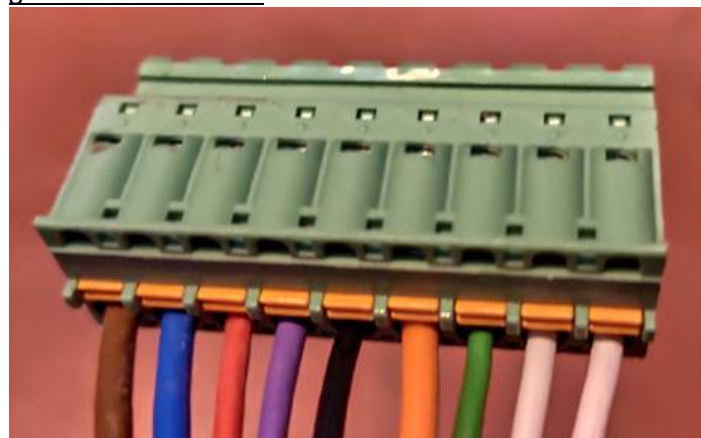
5 -Déconnecter du grand connecteur les 9 fils de couleur du faisceau (appui sur languettes orange) et garder ce connecteur.

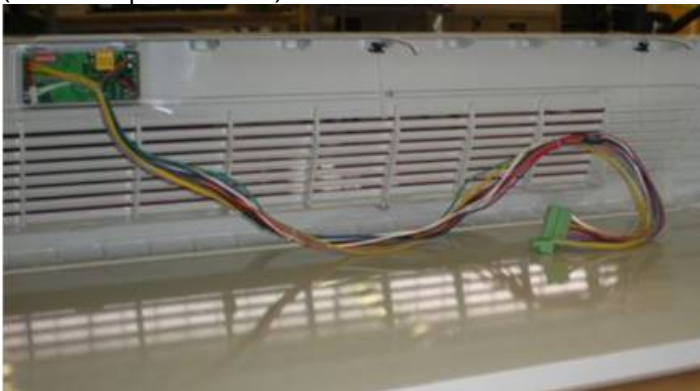
1- Disassemble the body after unpinning the two connectors of the old terminal

2- Detach the cable bundle from the body terminal (rilsan straps to be cut)

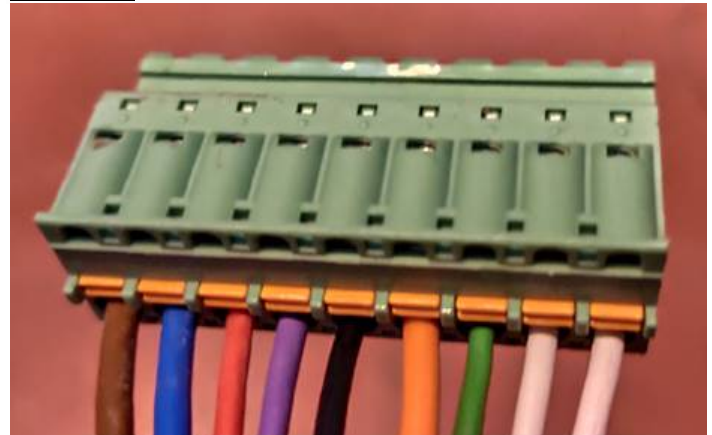
5 - Disconnect the 9 color threads from the large beam connector (press orange tabs) and keep this connector
